## Mammoth Estates Condominiums

### *Mammoth Lakes, CA*

# RESERVE STUDY

## Update "With-Site-Visit"

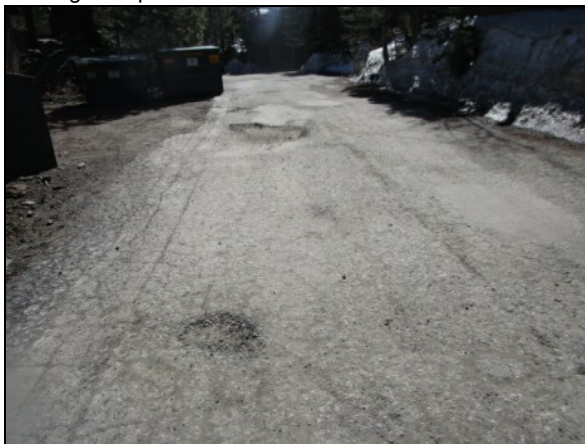
**Comp #: 202 Asphalt - Repair/Slurry****Approx Quantity: 56,000 GSF****Location:** Driveways, parking spaces, & walkways**Funded?:** No.**History:**

**Comments:** It was reported by the management that the association handles asphalt repairs and seal coating annually as an Operating expense. No Reserve funding is required.

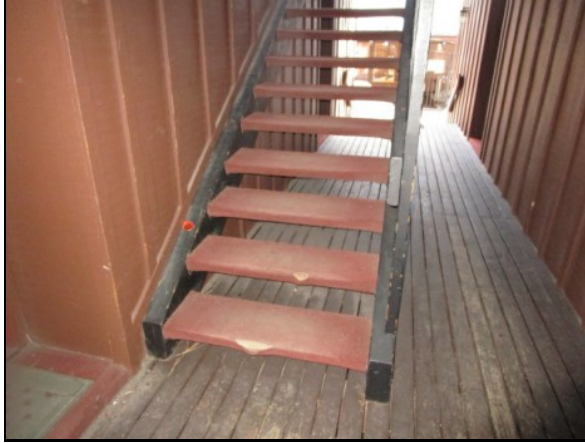
**Comp #: 514 Stairs/Railing - Repair****Approx Quantity: 1 Lump Sum****Location:** Building exteriors**Funded?:** No.**History:****Comments:** It was reported by your management that the association handles repair of the wood stairs and railings annually as an Operating expense. No Reserve funding is required. This includes any outdoor carpeting installed on the stair treads.**Useful Life:****Remaining Life:**

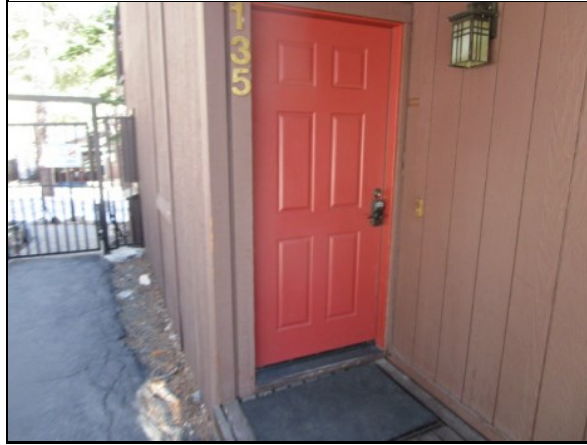
**Comp #: 1101 Front Doors - Repaint****Approx Quantity: 78 Doors****Location:** Unit entrances**Funded?:** No.**History:****Comments:** It was reported by the management that the association handles repainting of the front doors as needed as an Operating expense. No Reserve funding is required.**Useful Life:****Remaining Life:**

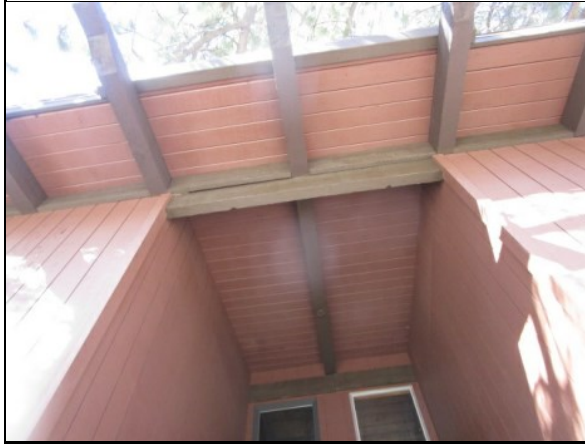
**Comp #: 1117 Exterior Wood Surfaces - Repair****Approx Quantity: 1 Lump Sum****Location:** Building exteriors, including balcony decks**Funded?:** No.**History:****Comments:** Signs of wear and tear. It was reported by the management that the association handles wood repairs annually as an Operating expense. No Reserve funding is required.**Useful Life:****Remaining Life:**

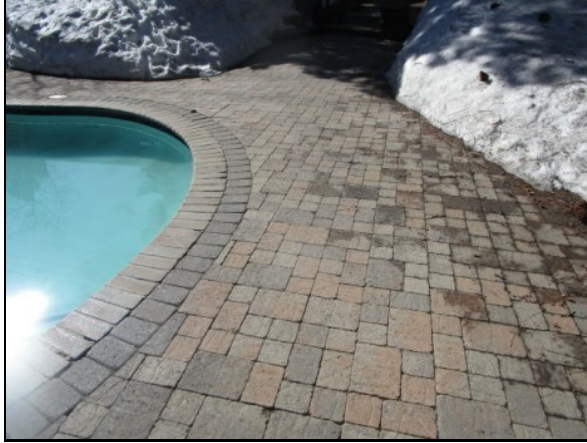
**Comp #: 1213 Pool Deck - Resurface****Approx Quantity: 3,200 GSF****Location:** Pool area**Funded?:** No.**History:****Comments:** Loose pavers at time inspection. It was reported by the management that the association handles the repairs (including paver replacement) annually as an Operating expense. No Reserve funding is required.**Useful Life:****Remaining Life:**

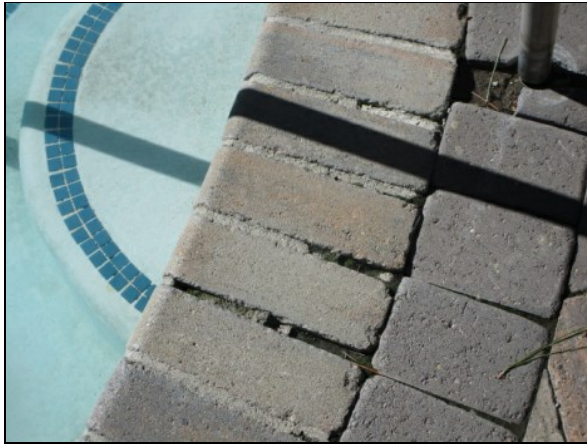
**Comp #: 1214 Pool/Spa Coping - Replace****Approx Quantity: 152 LF****Location:** Pool area**Funded?:** Yes.**History:****Comments:** Signs of moderate surface, but no detached or loose pavers. Replacement of the coping should be cycled with each deck replacement.**Useful Life:**  
25 years**Remaining Life:**  
13 years
