## Mammoth Estates Condominiums

### *Mammoth Lakes, CA*

# RESERVE STUDY

## Update "With-Site-Visit"

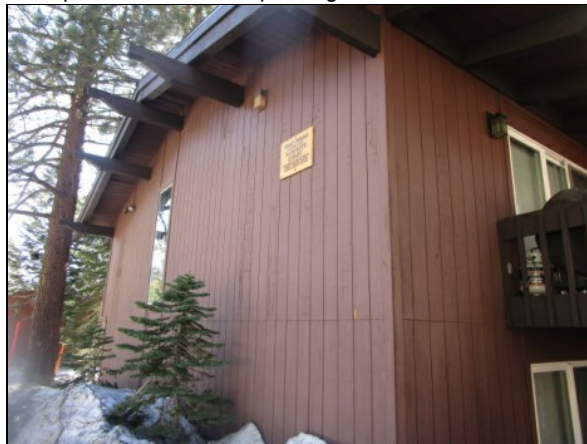
It was reported by management that the association handles the exterior repainting annually, in sections, as an Operating expense. There is no expectation to repaint the entire complex together. No Reserve funds will be used for repainting.

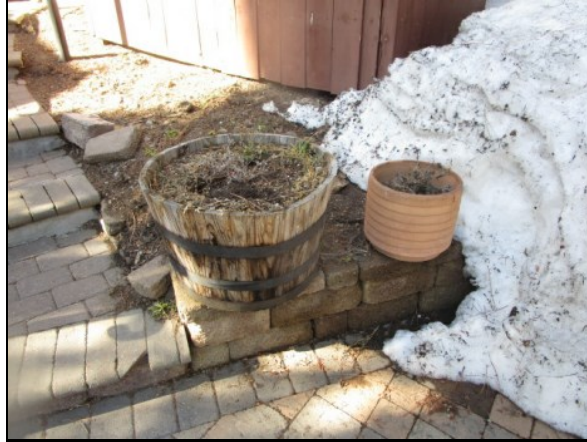
**Comp #:** 405 Planter Pots - Replace

**Comments:** Replacement value is too small for Reserve designation. Replace as needed as an Operating expense.

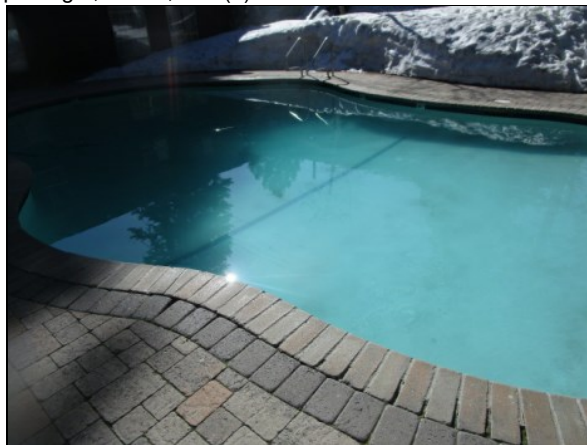
**Comments:** Plaster is showing heavy surface wear. Tiles are unattractive and deteriorated. Poor condition. Funding for the replastering of the pool surfaces every 10-15 years, and the replacement of the tile at longer intervals. Projects may also include the replacement of the handrail, pool light, ladder, and (2) skimmers.

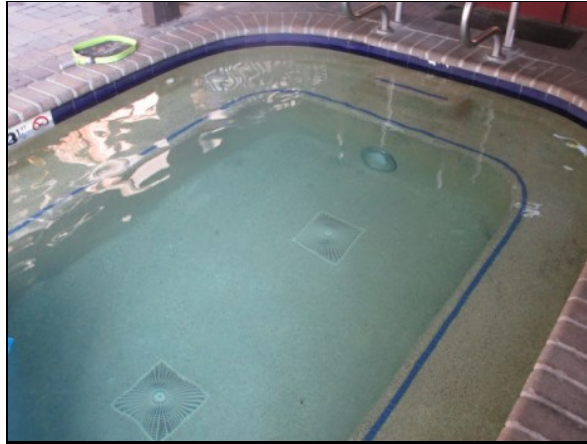
**Comments:** The spa plaster is showing heavy surface wear and discoloration. The tile is aged and damaged. Poor condition. Spa surfaces typically experience shorter useful lives than pool surfaces due to higher temperature and chemical balances. Funding for the replacement of the spa plaster every 5-7 years, and the replacement of the spa tiles at longer intervals. This project may also include the (2) rails, (1) light, & (1) skimmer.

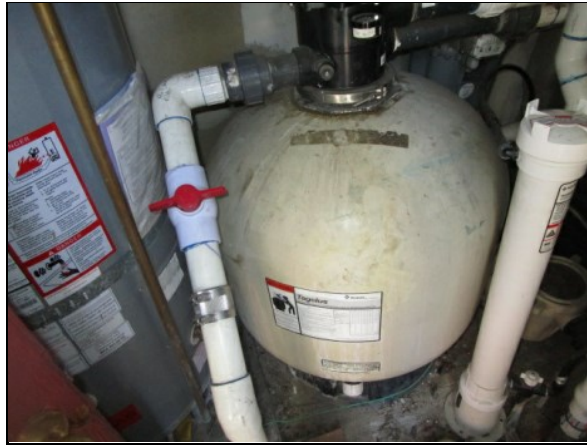
**Comp #: 1207 Pool Filter - Replace****Approx Quantity: 1 Pentair Filter****Location:** Pool equipment room**Funded?:** Yes.**History:**

**Comments:** No signs of heavy staining or active leakage. Replace the filter sand as needed as an Operating expense. Funding for periodic replacement of the filter.

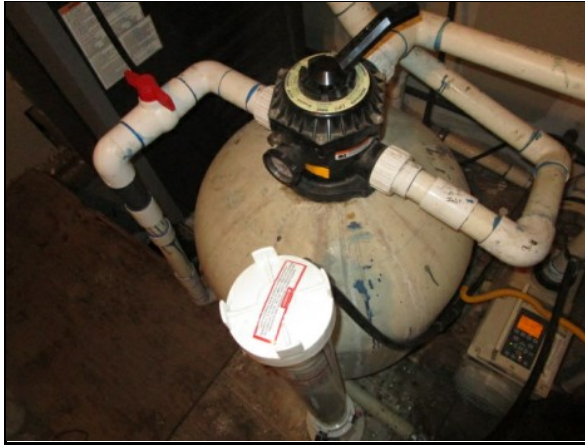
**Comp #: 1207 Spa Filter - Replace****Approx Quantity: 1 Pentair Filter****Location:** Pool equipment room**Funded?:** Yes.**History:****Comments:** Replace the filter sand as needed as an Operating expense. Funding for periodic replacement of the filter.**Useful Life:**

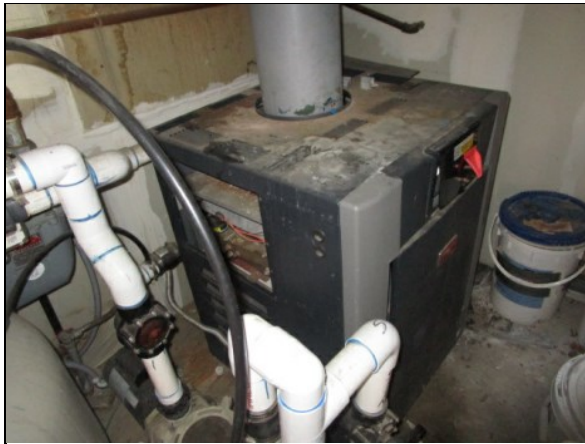
**Comp #: 1208 Pool Heater - Replace****Approx Quantity: 1 Raypak Heater****Location:** Pool equipment room**Funded?:** Yes.**History:** 2017**Comments:** The heater is older and has reached an extended useful life. Expect the need to replace in the near future based on age.**Useful Life:**

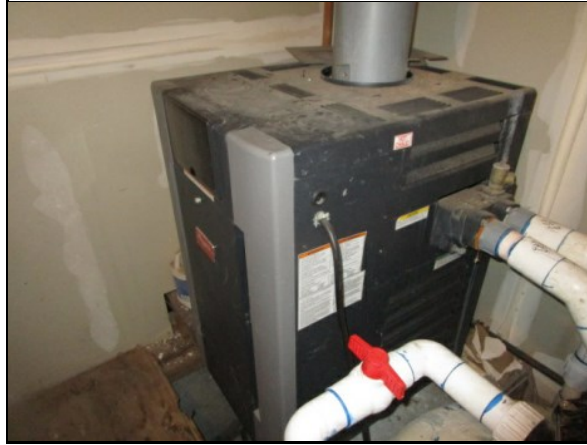
**Comp #: 1208 Spa Heater - Replace****Approx Quantity: 1 Raypak Heater****Location:** Pool equipment room**Funded?:** Yes.**History:****Comments:** The heater is older and has reached an extended useful life. Expect the need to replace in the near future based on age.**Useful Life:**

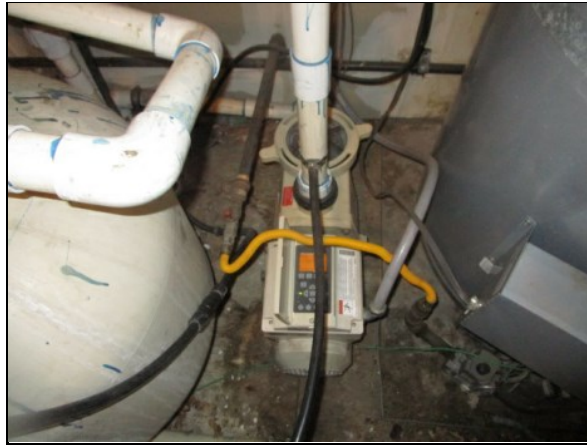
**Comp #: 1210 Pool/Spa Pumps - Partial eplace****Approx Quantity: 1 of (4) Pumps****Location:** Pool equipment room**Funded?:** Yes.**History:** 2023/2024 - Spa Filter Pump**Comments:** The pumps vary in age. There is no expectation to replace all pumps at the same time. Funding for ongoing replacements of individual pumps as they fail. The pumps should be serviced on a regular basis as an Operating expense. The cost to replace individual pump motors is too low for Reserve designation. Replace motors as needed as an Operating expense. Funding for the replacement of the entire pump assembly from Reserves.**Useful Life:**

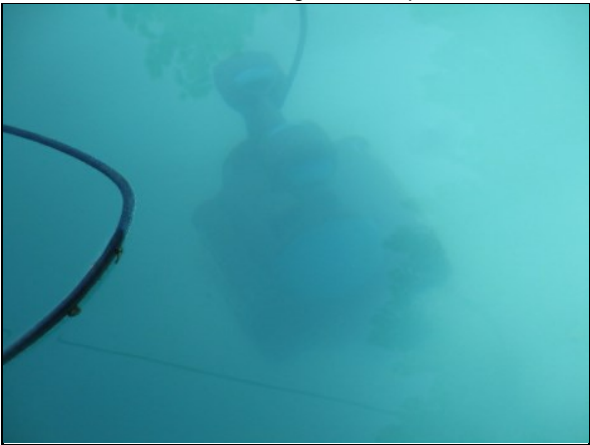
Comp #: 1230 Pool Cleaner - Replace

Comments: Replacement value is too small for Reserve designation. Replace as needed as an Operating expense.

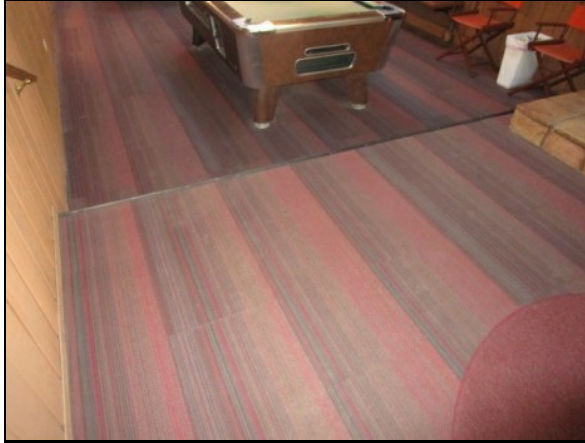
**Comp #: 601 Carpet - Replace****Approx Quantity: 62 GSY****Location:** Clubhouse game room**Funded?:** Yes.**History:** 2023/2024

**Comments:** Good condition. Funding for periodic replacements of all common area carpeting to maintain a uniform and attractive appearance throughout. Any planned interior repainting projects should be completed before the carpet replacement is started to avoid damaging any new floors. Regular cleaning and shampooing of the carpeting should be handled as an Operating expense.

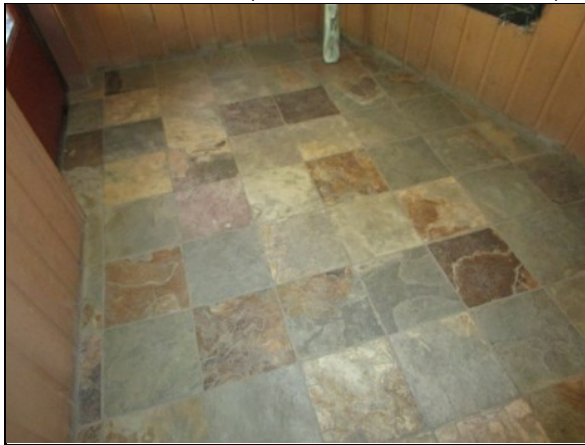
**Comp #: 603 Tile Surfaces - Replace****Approx Quantity: 590 GSF****Location:** Pool restrooms, laundry room, check-in lobby**Funded?:** Yes.**History:**

**Comments:** Floors = 438 GSF, Walls = 152 GSF. Good condition. This project should be cycled with the restroom remodeling to replace these tiles at the same time as the restroom tiles (not included with this line-item).

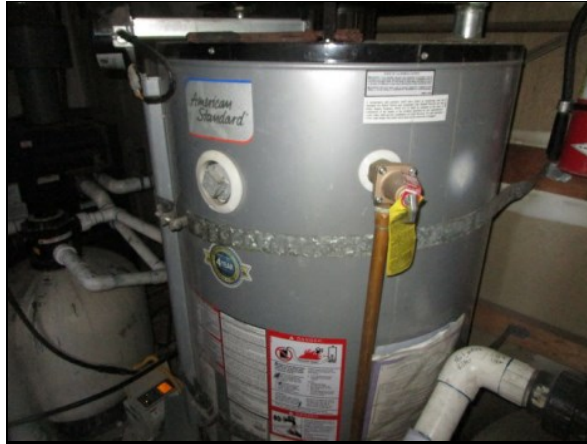
**Comp #: 803 Water Heater - Replace****Approx Quantity: 1 American 80 Gal****Location:** Clubhouse pool equipment room**Funded?:** Yes.**History:**

**Comments:** The function of the water-heater was not tested as part of the scope of this reserve study. Water-heater tanks typically last 10-12 years. The tank should be flushed annually as an Operating expense. Water-heater tanks should be replaced proactively based on age and service vendor recommendations since failure is usually very sudden and could result in expensive interior damage and prolonged down-time while the heater is being replaced. Serial #B17-0905.

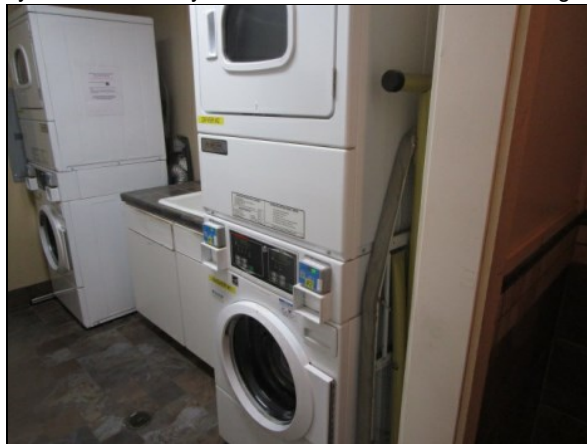
**Comp #: 901 Laundry Appliances - Replace****Approx Quantity: 2 Sets****Location:** Laundry room**Funded?:** No.**History:**

**Comments:** The washers and dryers are leased by the association. No Reserve funding required.

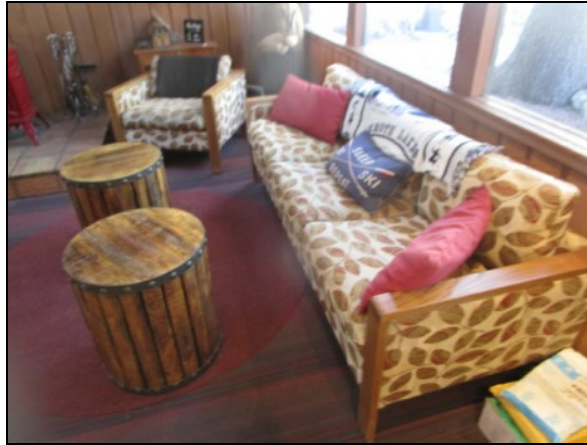
**Comp #: 903 Furniture/Fixtures- Partial Replace****Approx Quantity: 27 Fixtures****Location:** Clubhouse common areas**Funded?:** Yes.**History:**
