Report #: 11378-0

Beginning: July 1, 2022

RESERVE STUDY
Update "With-Site-Visit"

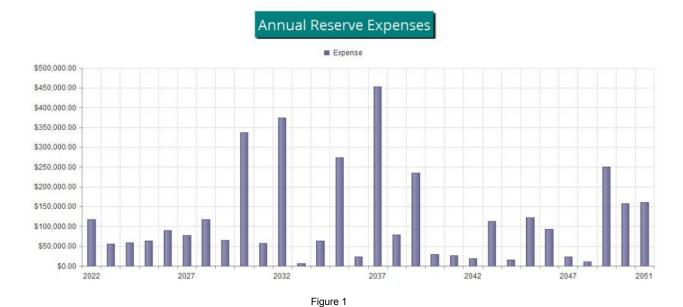
The figure below summarizes the projected future expenses at your association as defined by your Reserve Component List. A summary of these components are shown in the Component Details table, while a summary of the expenses themselves are shown in the 30-yr Expense Summary table. Note the future years of high projected Reserve expenses.

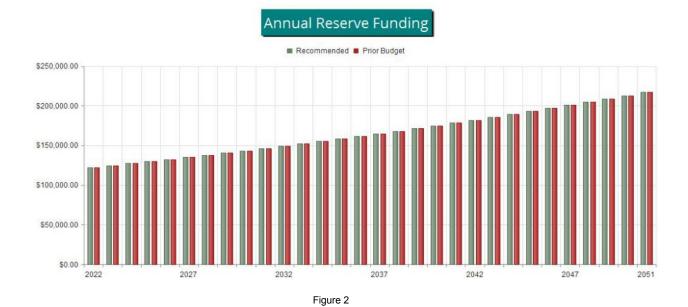
Based on your current Percent Funded and your near-term and long-term Reserve needs, we are recommending budgeted contributions of \$10,190 per month this Fiscal Year. The overall 30-yr plan, in perspective, is shown below. This same information is shown numerically in both the 30-yr Summary and the Cash Flow Detail tables.

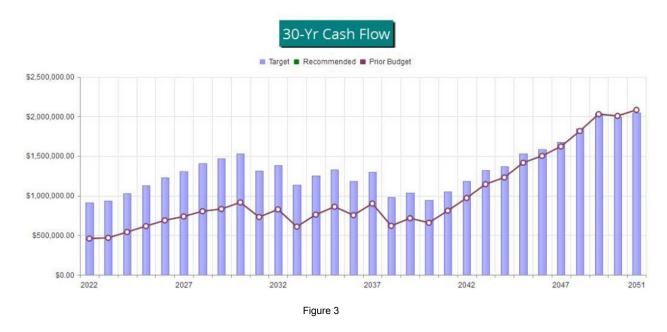
The following chart shows your Reserve balance under our recommended Full Funding Plan and at your current budgeted contribution rate, compared to your always-changing Fully Funded Balance target.

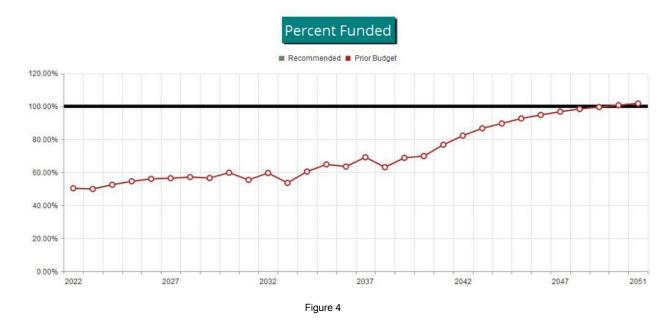
This figure shows the same information plotted on a Percent Funded scale. It is clear here to see how your Reserve Fund strength approaches the 100% Funded level under our recommended multi-yr Funding Plan.
